Health PEI

SAFER PRACTICE NOTICE

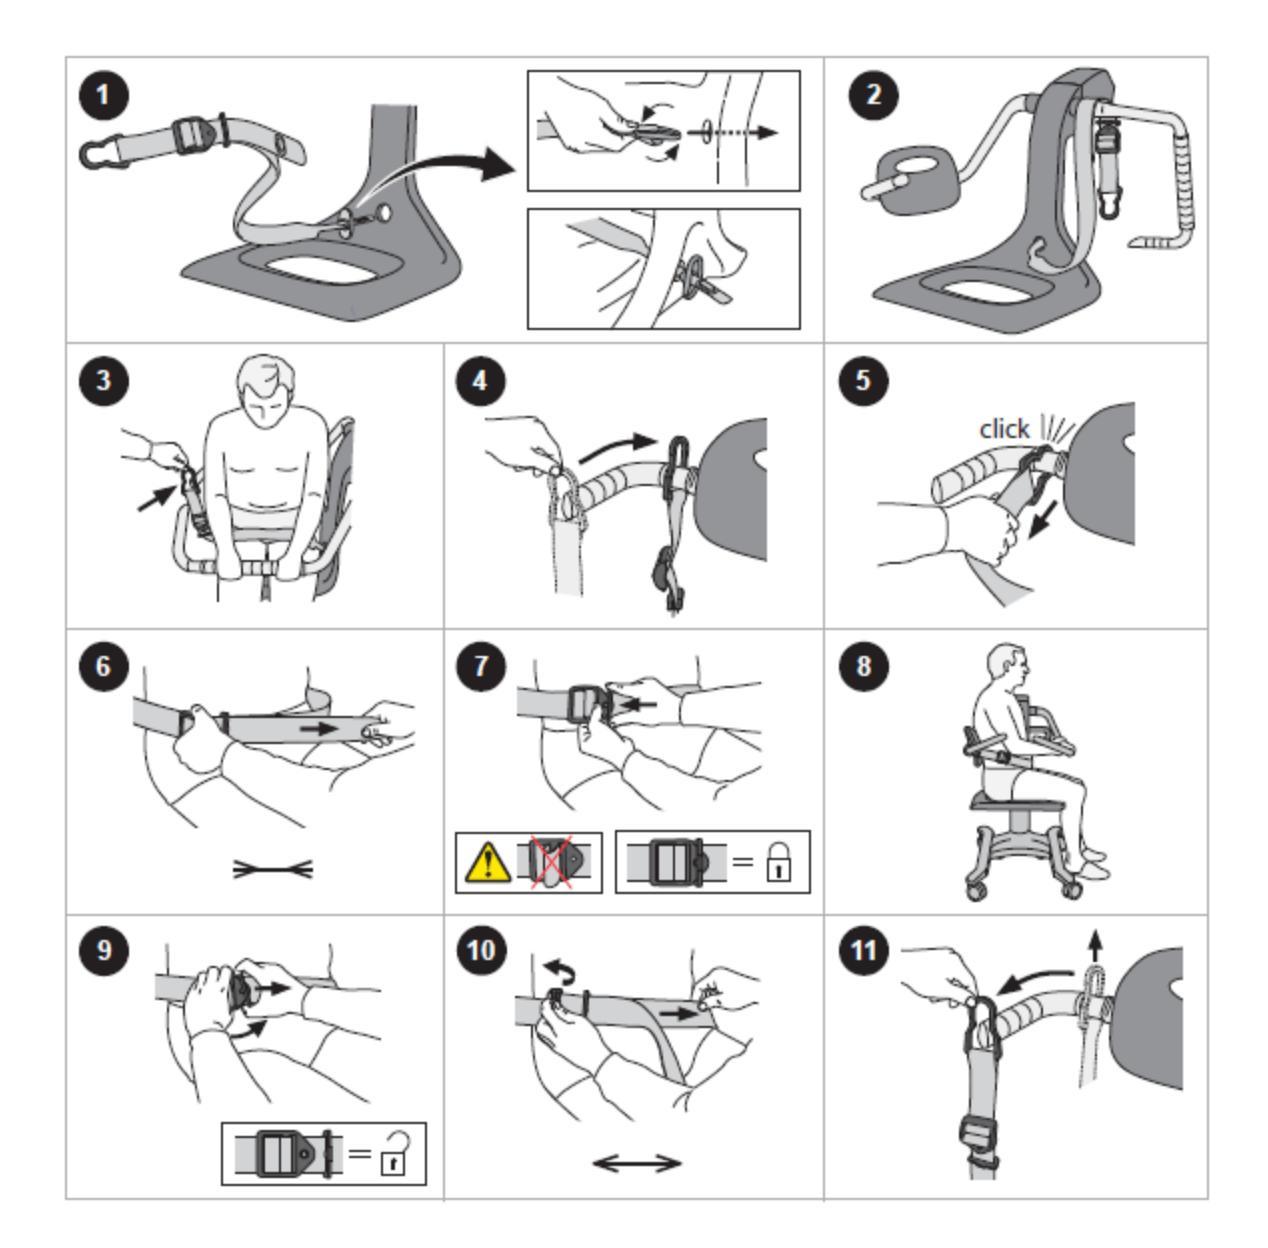
08.CD.04_3 • 10/2019

- Assess residents upon admission to determine an appropriate method of bathing and the bathing equipment required.
- Reassess residents as their physical or cognitive abilities change to determine if the current method of bathing is still appropriate.
- Inspect safety belts on tub chair lifts, tub stretcher lifts and mesh chairs used in tubs prior to every use to ensure they are in good working condition with no signs of fraying or damage. Do not use any frayed or damaged items.
- Inspect all safety belts on tub chair lifts, tub stretcher lifts, and mesh chairs used in tubs on a weekly basis to ensure that they are in place, undamaged, and working correctly. See the attached PDF documents for the two possible versions of the safety belt for the Alenti Tub chair, depending on the model(s) of Alenti Tub chair at your facility.
